## Fire in a block of flats – Svenljunga

*Coldcutsystems AB. Based on 2010 MSB report 'Cutting Extinguishing Concept', SERF & SP*

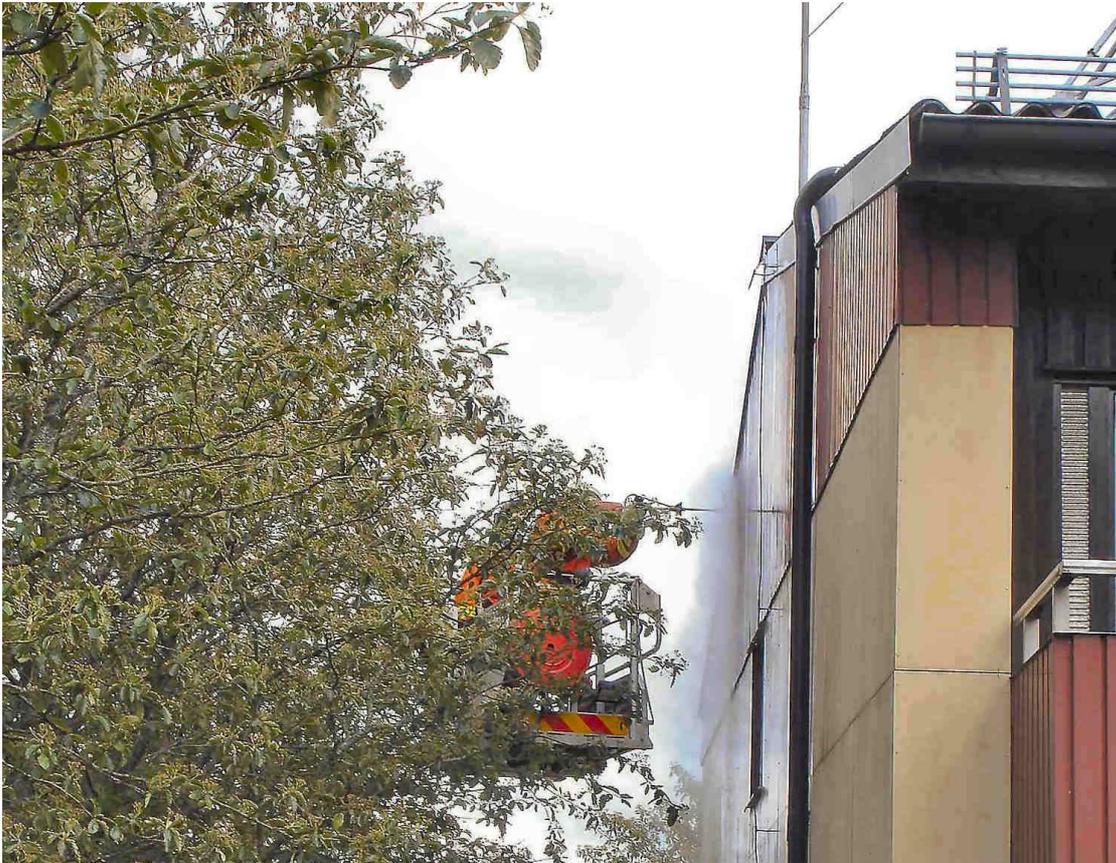
During the intervention with the Cobra™ from the gable there is a rapid change from black to off-white smoke and steam. As the Cobra™ operation continues the steam gradually fills the attic and stream out through the various openings.

After a while a hole is cut in the middle of the roof to gain access to the attic from the outside but when it is ready it was found that fire in the attic was already extinguished by the Cobra™ operation from the gable.

The total operation last for about an hour. It was concluded that the cutting extinguisher had a crucial role in extinguishing the fire although it was not applied properly through the gable until after 27 minutes into the operation. The waterjet, which breaks up after about five meters, was most efficient when used in a long straight beam right into the attic trying to avoid hitting building parts. That the Cobra™ operation was assisted from the ground with instant information from an IR camera was also part of the success.

*The Cobra is here applied from the gable furthest away from the fire.*
