Fire in a motor cycle shop - Ulricehamn

Coldcutsystems AB. Based on 2010 MSB report 'Cutting Extinguishing Concept', SERF & SP

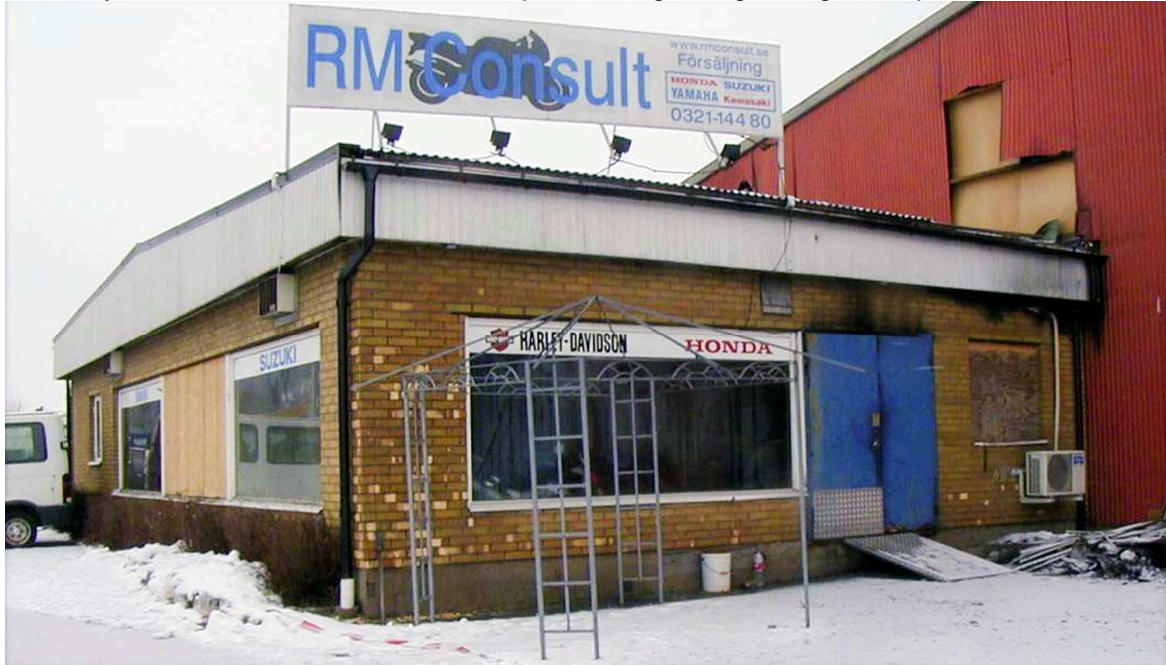
The fire was in the motorcycle shop in front but it threatened the much larger building to the right.

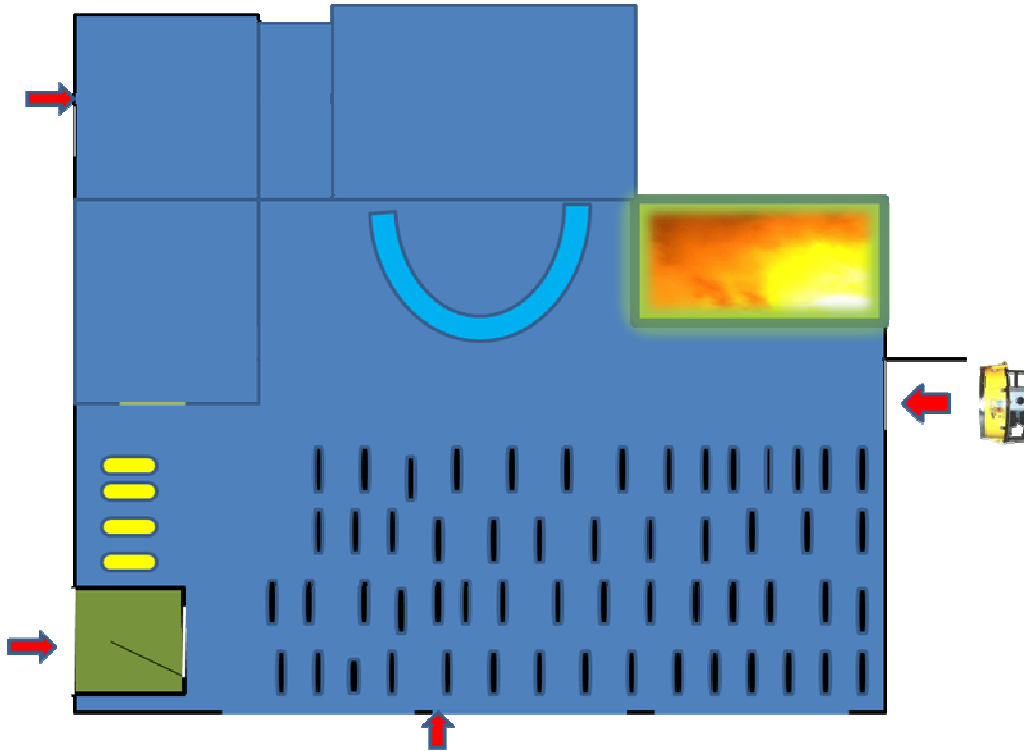
This drawing shows the fire-affected compartment, which is about 15 x 8 meters, at the motor cycle shop. The red arrows indicate where the cutting extinguisher was deployed. The short black lines are the motorcycles.

There is no indication of any people inside the MC shop but it is full of motor cycles weighing up to 250 kg each. As the temperature in the fire room is very high and visibility is limited it is decided to cool down the fire gases from the outside using the Cobra™ cutting extinguisher rather than mounting a risky BA attack. The Cobra™ is first applied from the front side and then subsequently on the gable and finally through the blue double doors on the backside of the shop. Meanwhile measures are also taken to secure the inside of the bigger building material shop but the fire has not spread to here yet.

When the fire gases have been cooled down the door is opened to the shop and a PPV fan in combination with the Cobra™ is used to improve visibility inside by blowing out steam and fire gases. The Cobra™ is then turned off as the BA-team is ordered in to take care of remaining embers in the roof and elsewhere. This is 25 minutes after the operation started.
